**Report about an endoscopic inspection of the gear box  
of a wind turbine**

**GA-Nr.: 1598.G80.05.18**

**Site:** Bomber/Germany

**Number and type:  
of turbines** 1 x Gamesa G 80

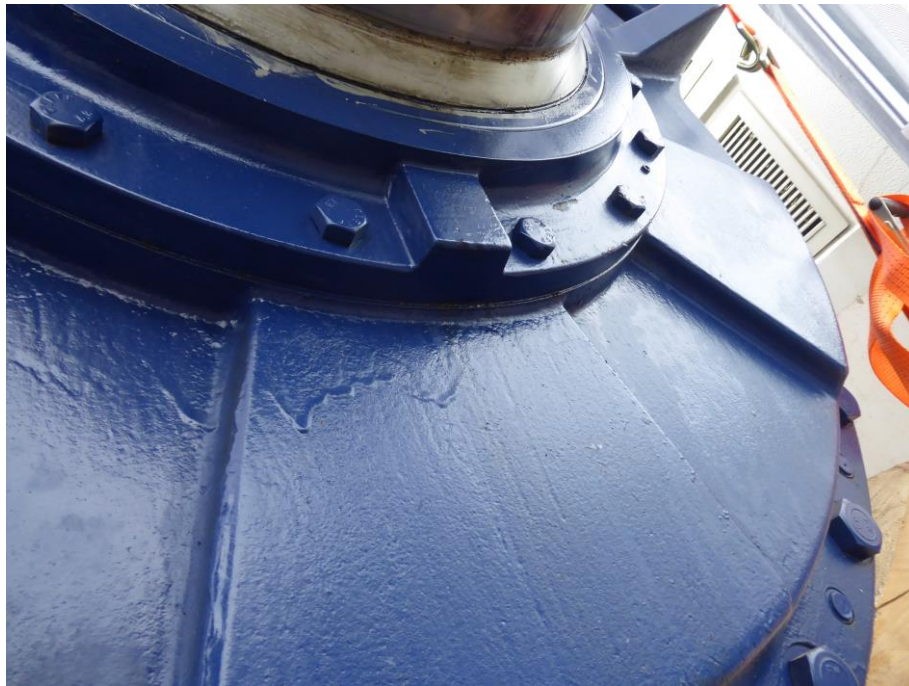
**Picture 1**

Picture 1 indicates that there is an oil loss through the labyrinth seal of the drive stage.

The leaks at the drive shaft and the output shaft are low and should be checked and cleaned regularly. The leakage at the filter fittings must be permanently remedied by the manufacturer as part of the maintenance. In addition, the paper filter of the gearbox renewal must be renewed.

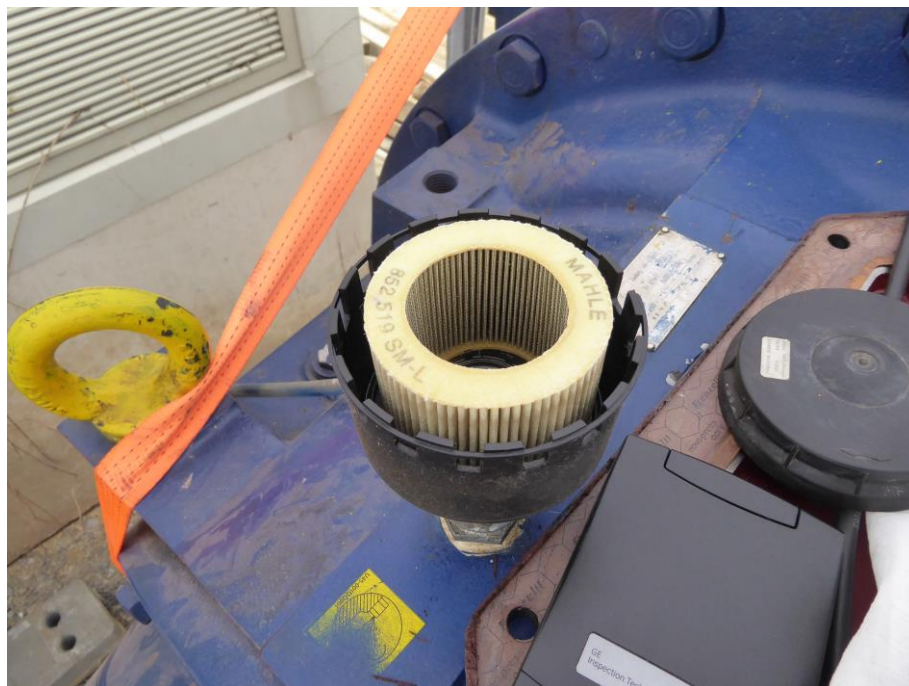
**Picture 2**

The gear air filter shows a little bit oil on the paper on picture 2.

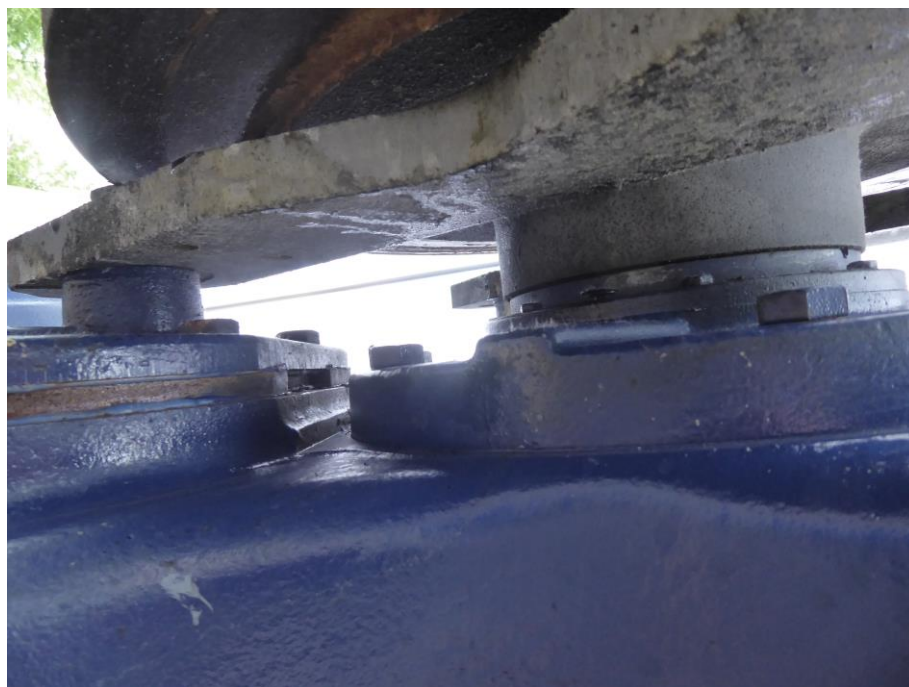
**Picture 4**

At the shaft bushing of the output stage an oil loss in the area of the labyrinth seal is visible also as picture 4 shows.

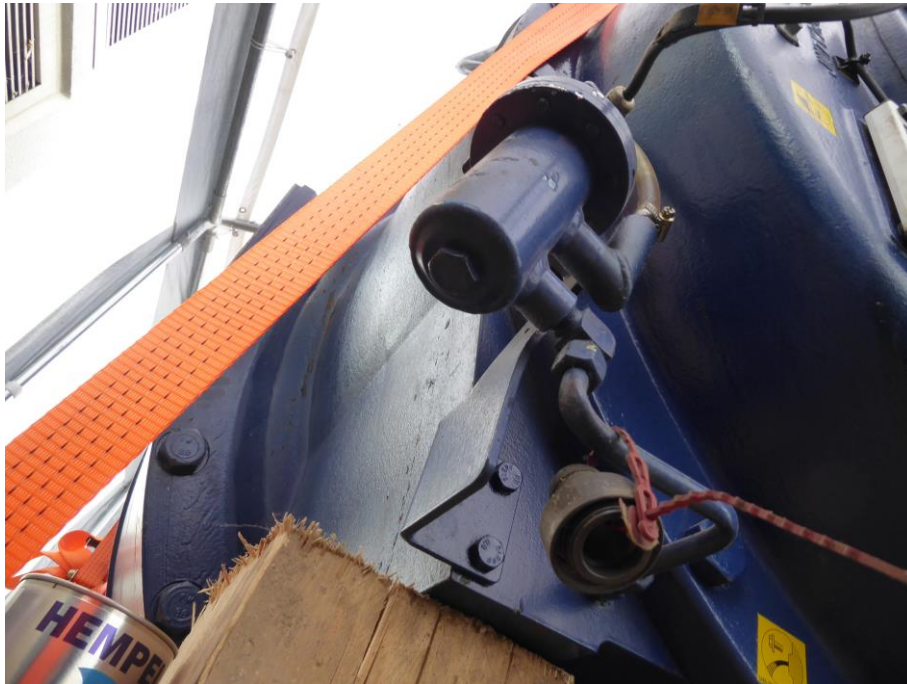
**Picture 5**

As recognizable on picture 5, the filter housing of the fine filtration indicates a slight leakage.

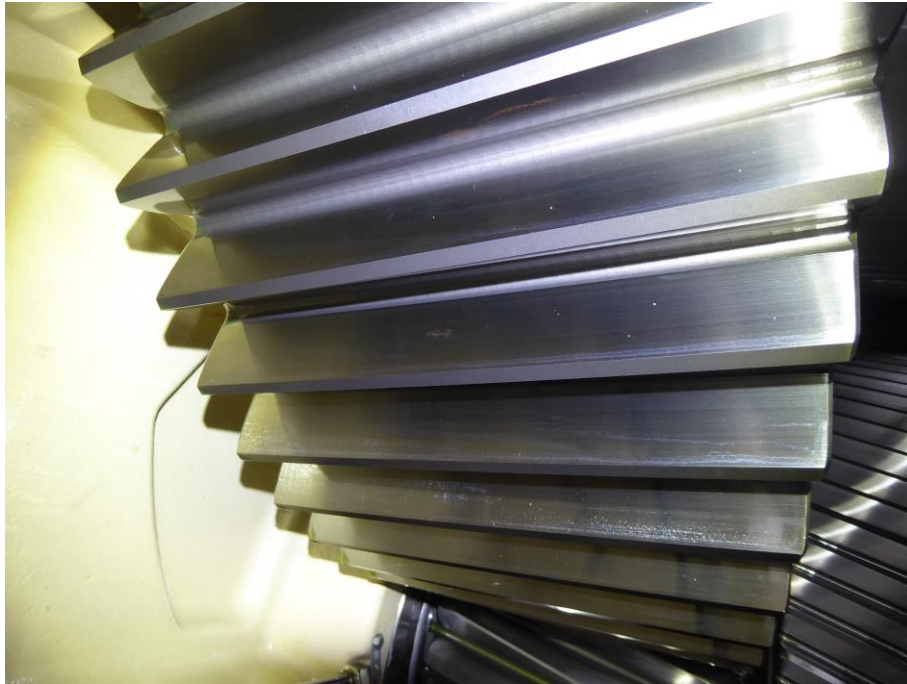
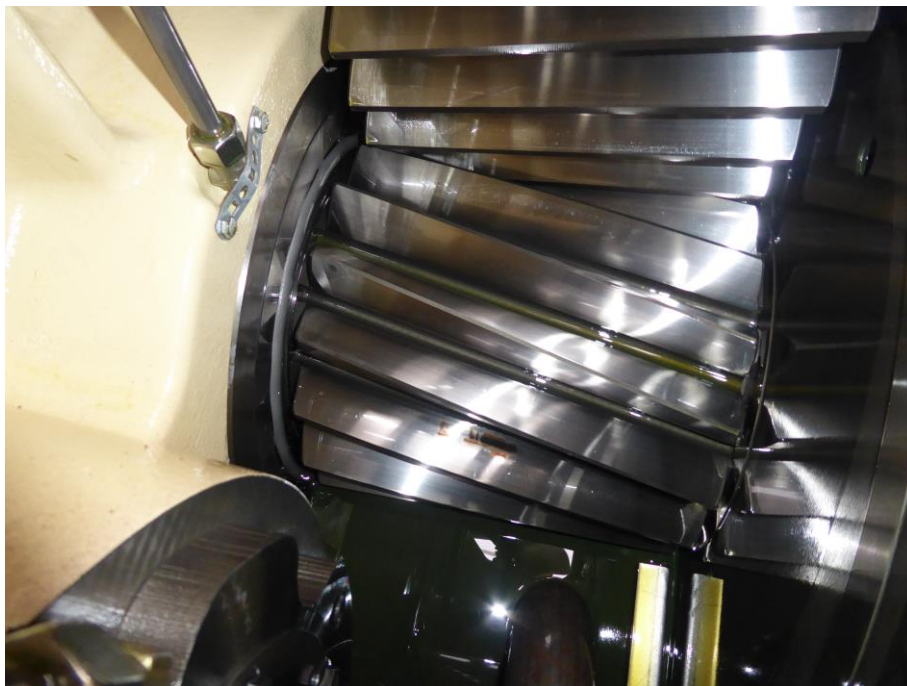
Pictures 6 and 7 show the input stage of the spur gear part. The load flanks of this tooth pair show a marginal frontal loading of the pinion with distinctive line forming in the tooth base of the gear. Furthermore a slight insufficient correction by grindings with a contact pattern alignment towards the generator is recognizable.

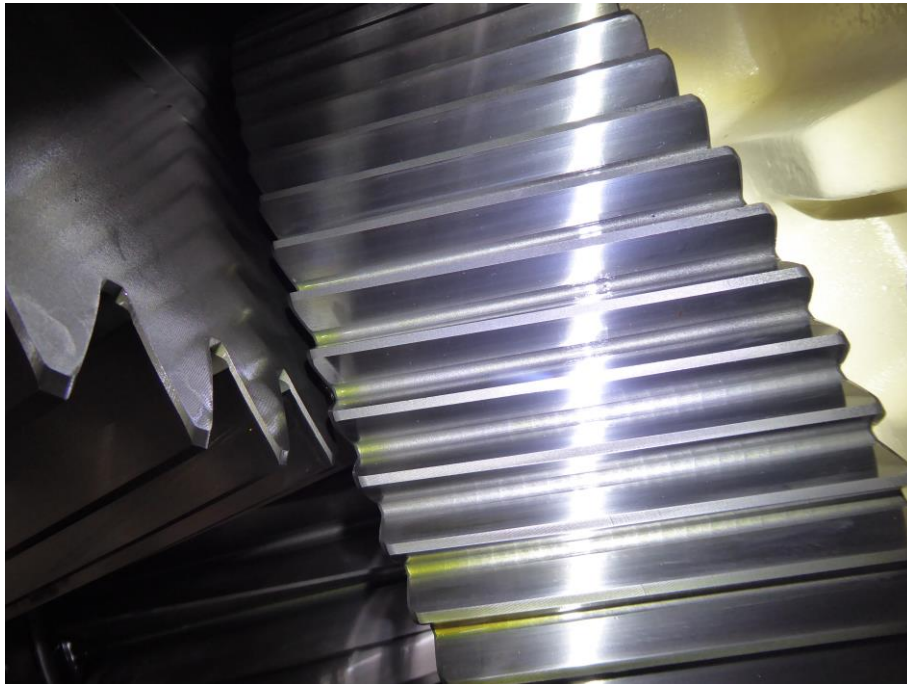
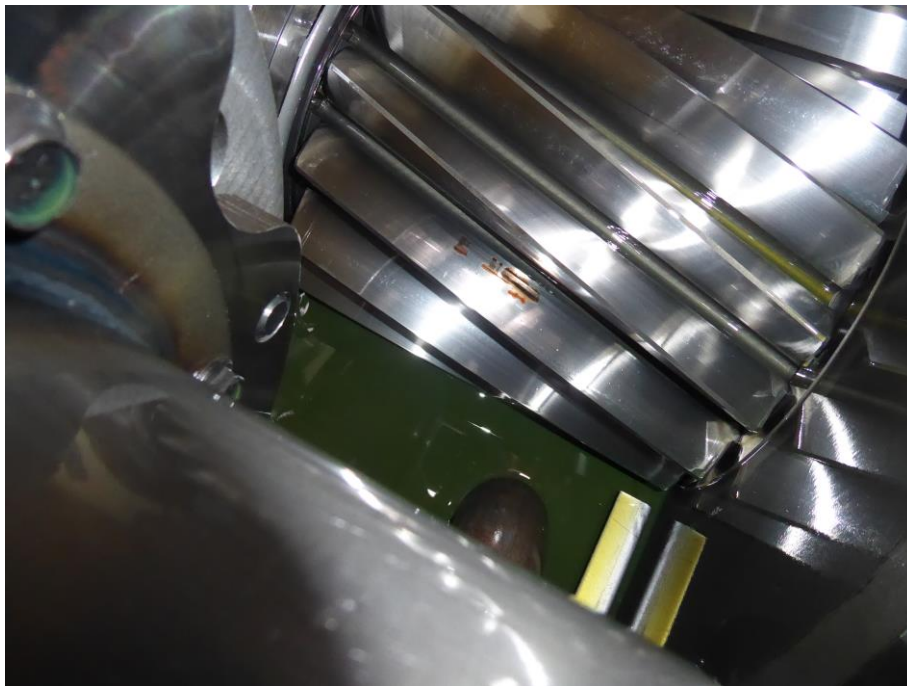
Pictures 8 and 9 show the output stage of the spur gear part. Here shows the load flanks also a marginal frontal loading of the pinion with distinctive line forming in the tooth base of the gear. In addition, an insufficient corrective grinding to a supporting image orientation towards the rotor and single arrest marks can be seen.

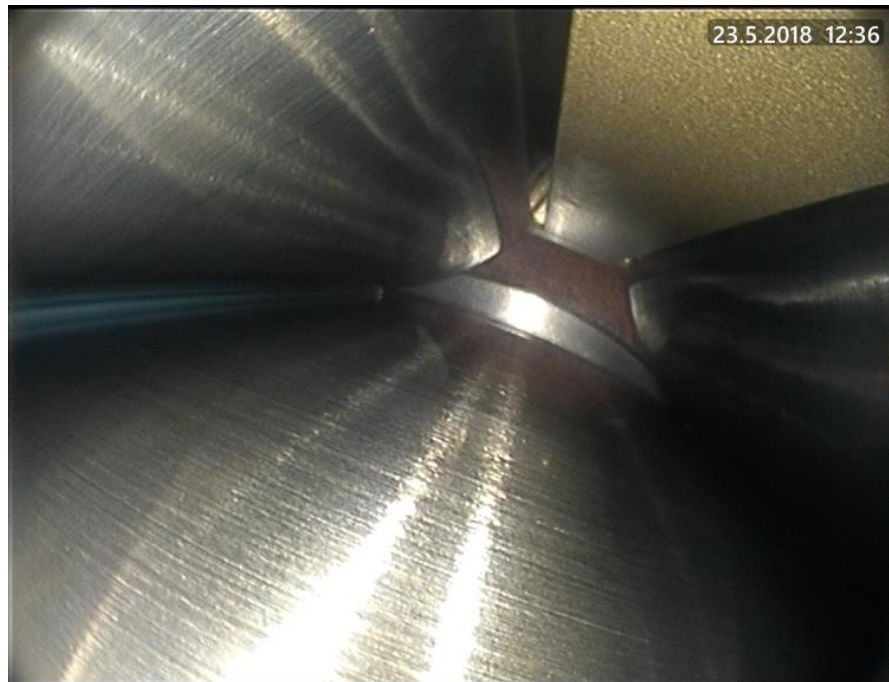
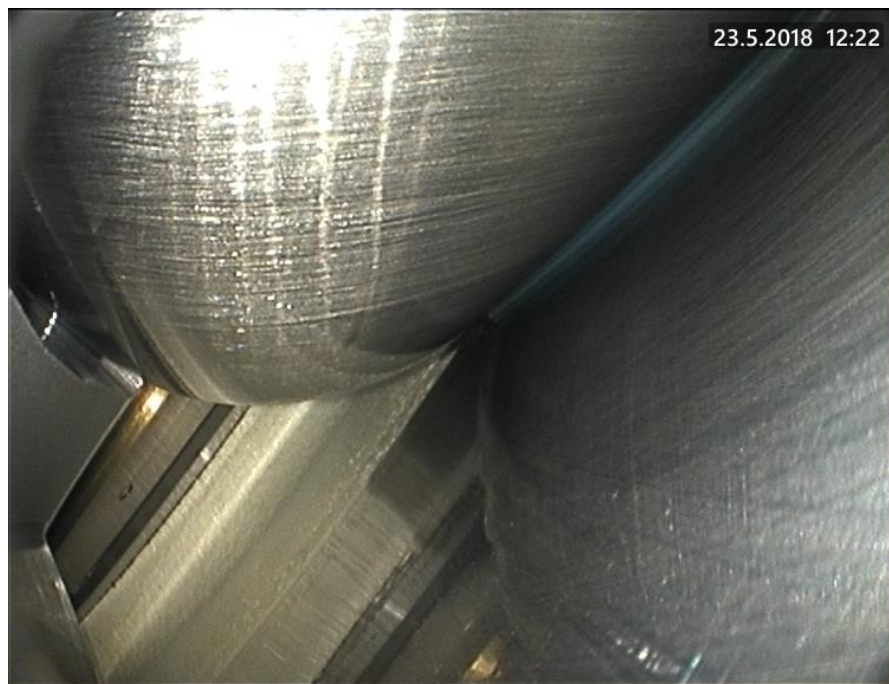
Picture 10 shows the rotor side bearing of the output stage and picture 11 shows the bearing of the drive stage generator sided. All visible bearings of the spur gear stage indicate just operational running marks with slight scoring in sense of rotation which present harmless overall.

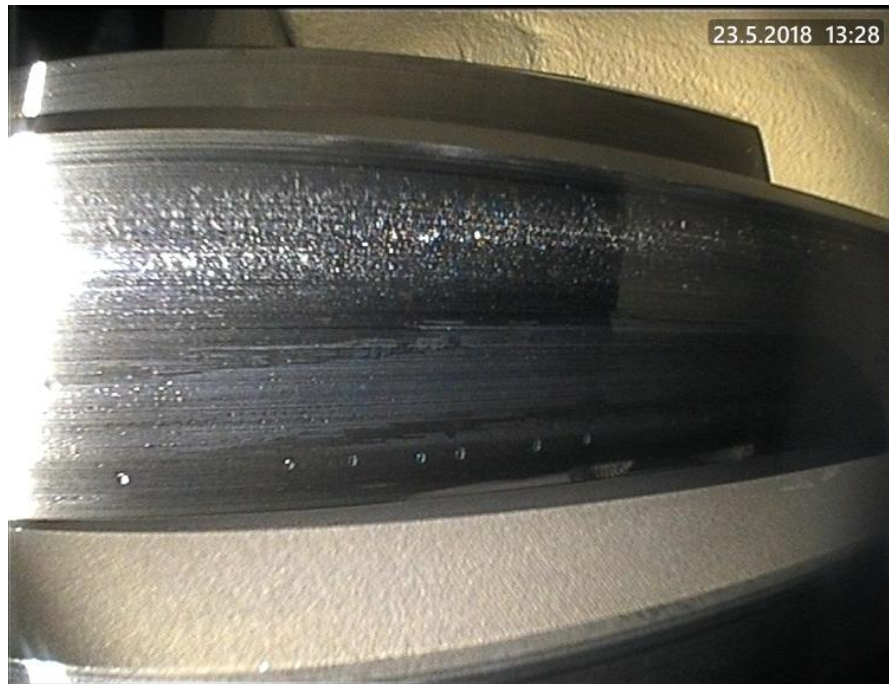
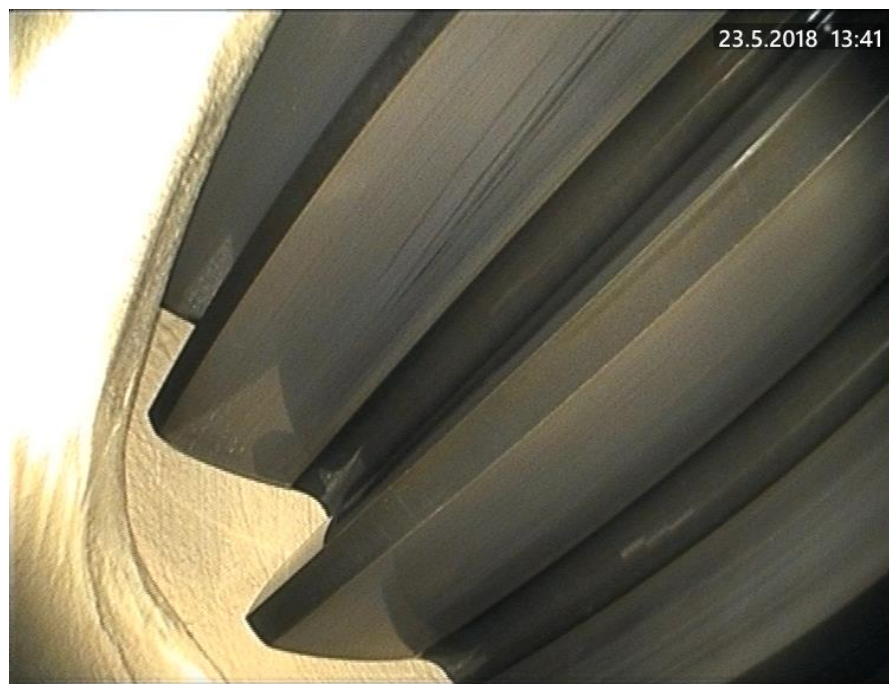
Pictures 12 and 13 show the tooth flanks of the first and third planetary gear of the planetary stage. A distinctive line forming in the tooth base is recognizable and the load flanks show a slight roughening of the tooth surfaces. Furthermore a contact pattern alignment towards the generator as well as some standstill marks are visible.

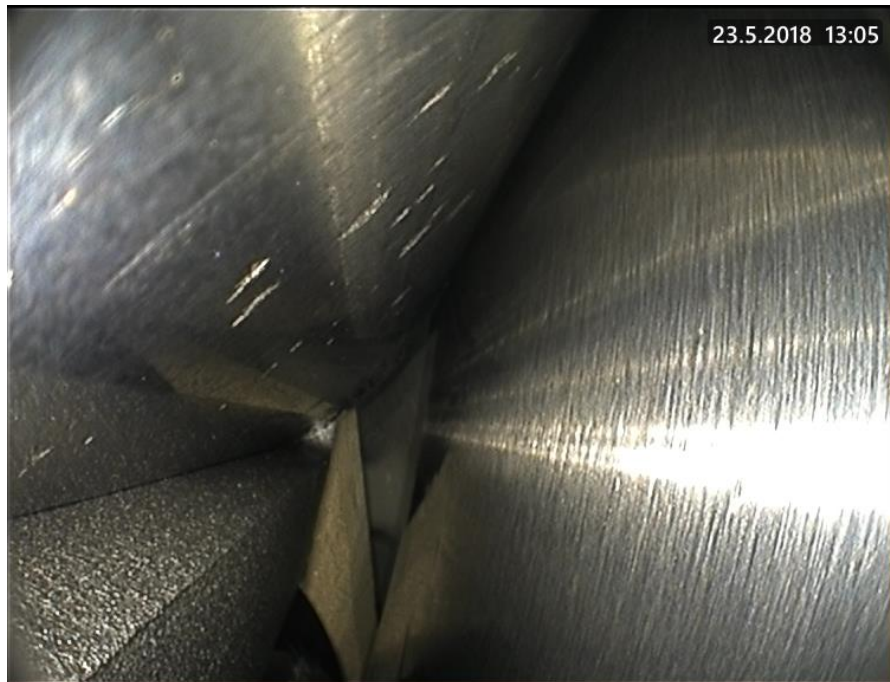
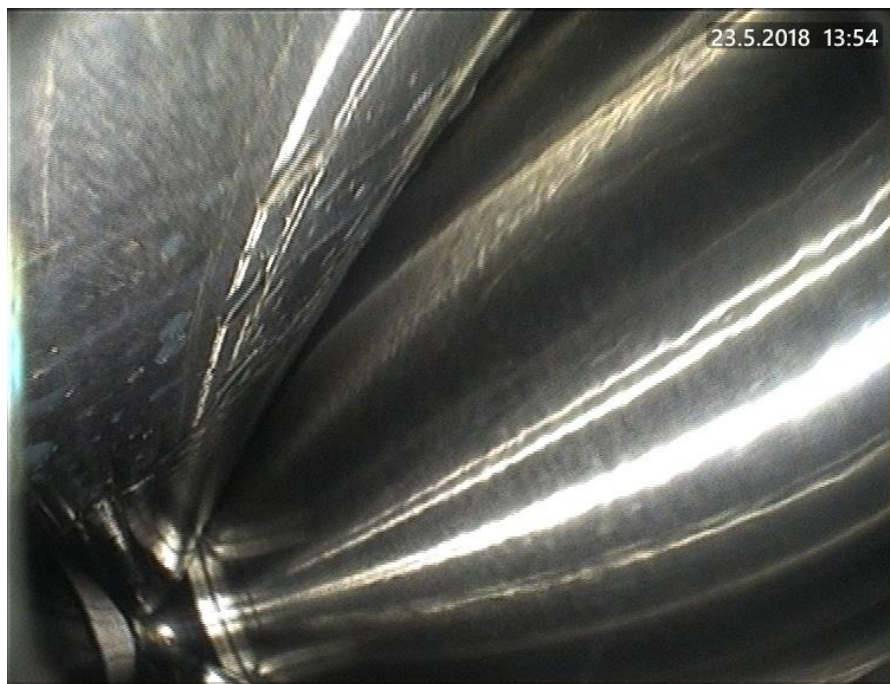
The bearings of the planetary gears indicate running marks with slight scoring in sense of rotation and some metal particle as recognizable on pictures 14 and 15, which is unusual to be regarded as easy and requires observation.

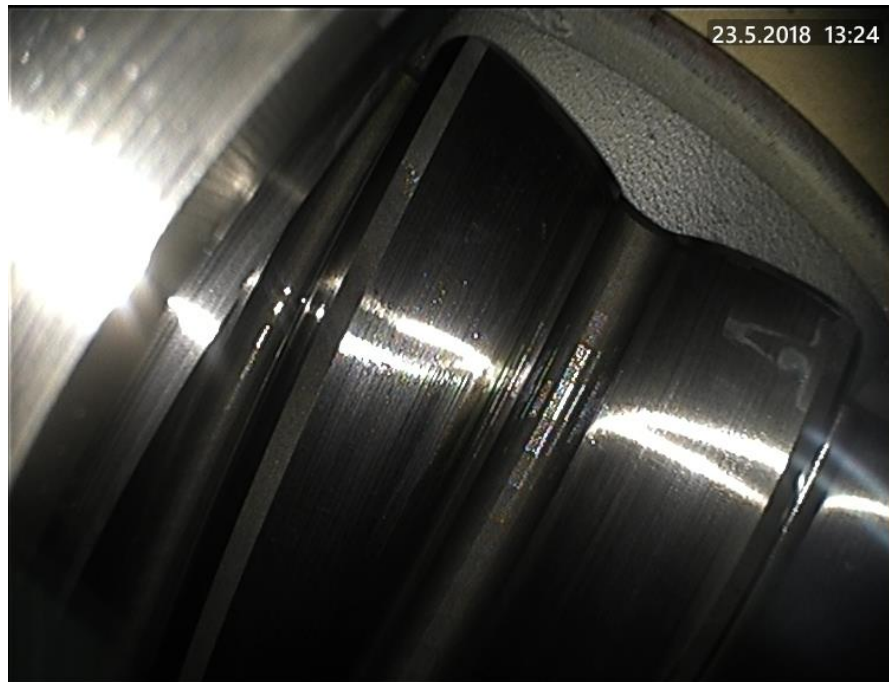
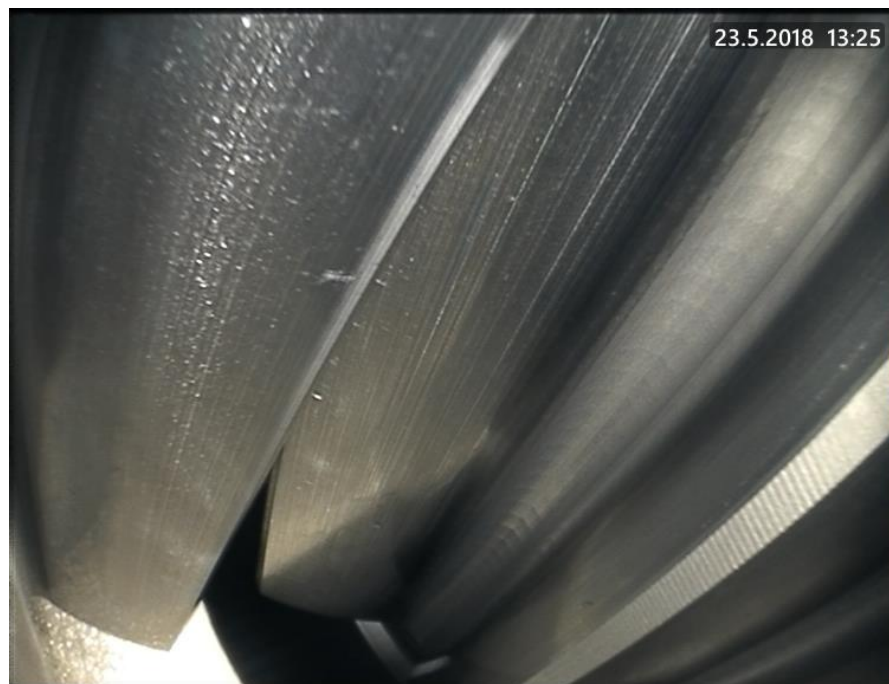
Pictures 16 and 17 show the sun gear of the planetary stage. In the tooth base a distinctive line forming is caused by the frontal loading of the planetary gears. Furthermore, a contact pattern alignment towards the generator and a roughening of the load flanks is recognizable.

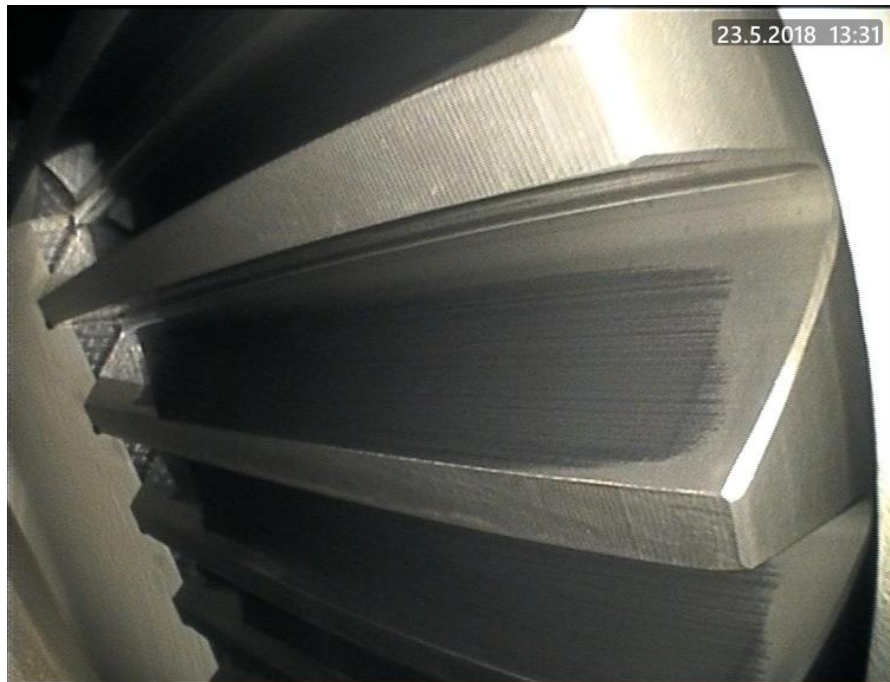
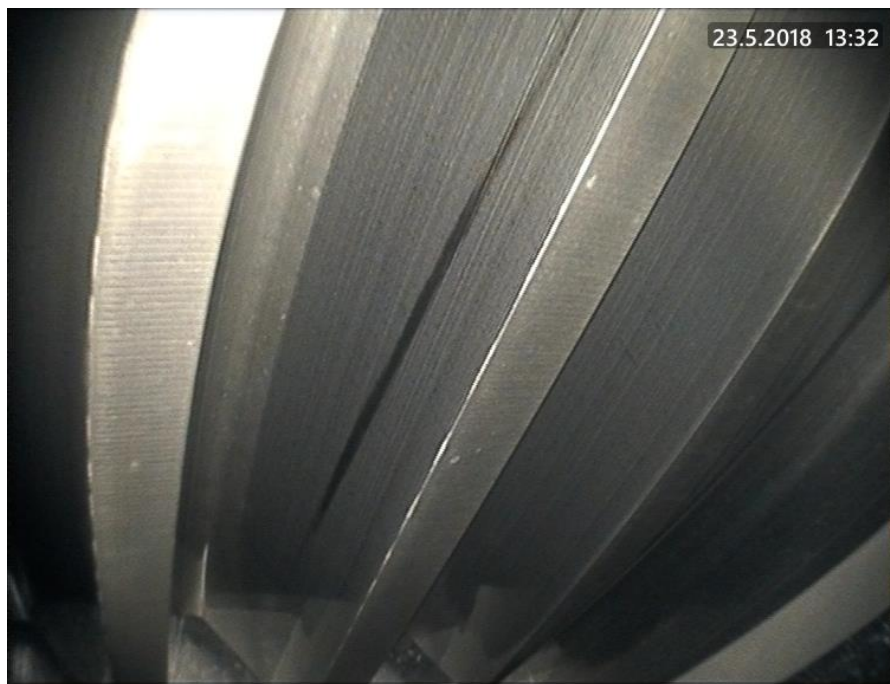
On pictures 18 and 19 the tooth flanks of the ring gear are imaged. Here is a contact pattern alignment to the rotor out and there are some pronounced standstill sichtbr sightbr, but they are not questionable.

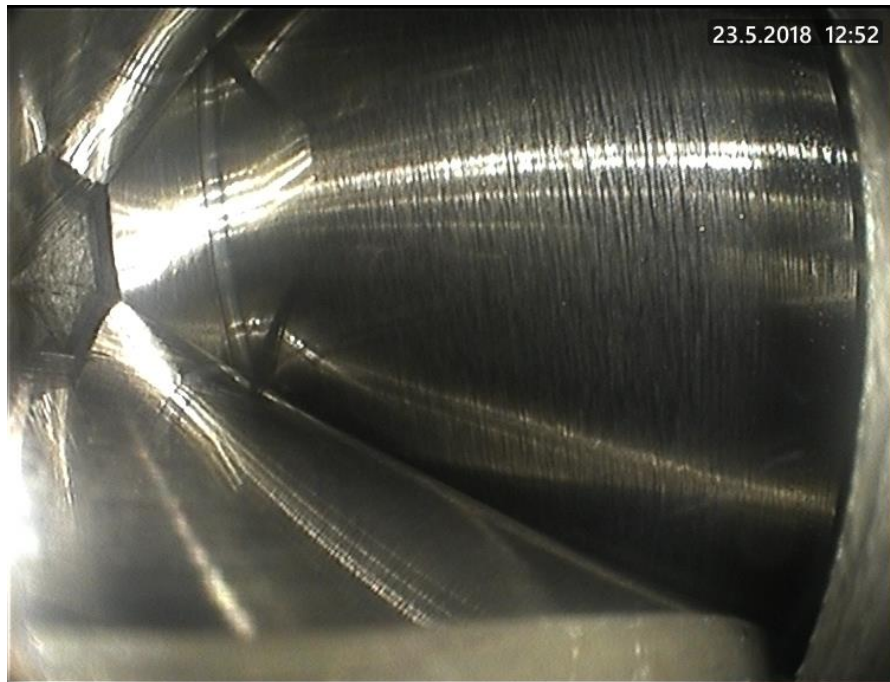
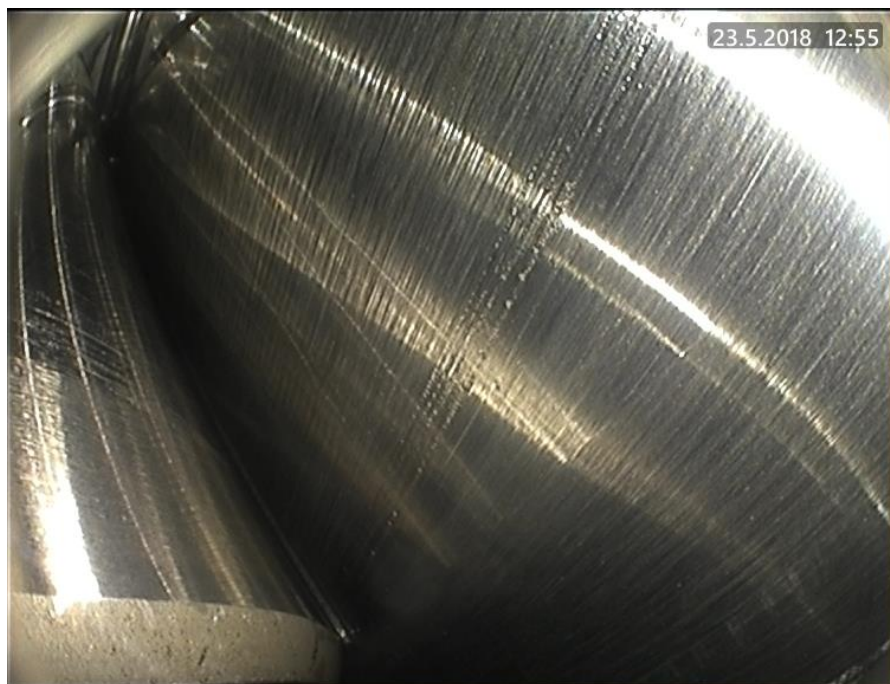
On pictures 20 and 21 the rotor side bearing of the planetary carrier is recognizable. The bearings show, in addition to the normal running tracks, individual grooves that indicate slight roughening.
