## BLADE REPORT

| | BLADE INSPECTION REPORT | Fecha:/Date: 17/09/20<br>Edición:/Edition: 00 |

| Scope of the repair: | BLADE INSPECTION | Intervention type: | GROUND |

| Type of WTG | VESTAS V80 |

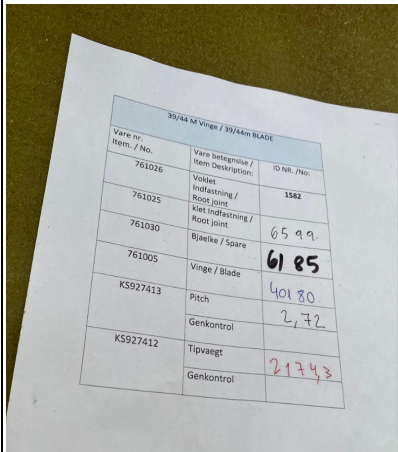
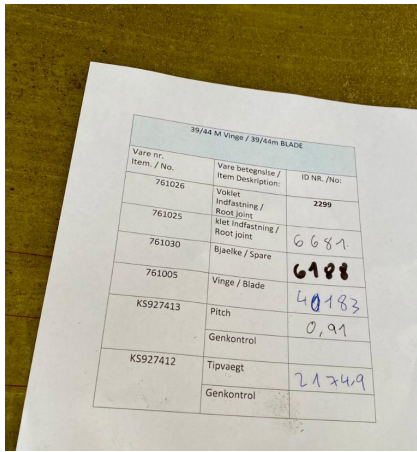
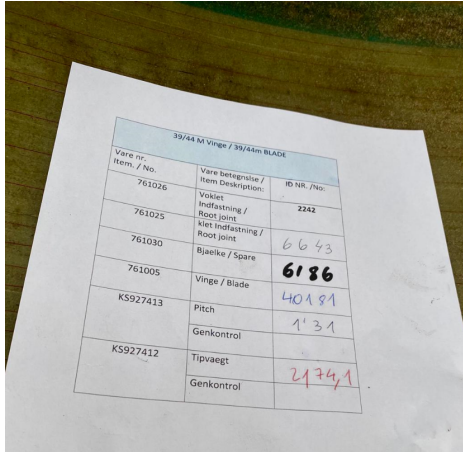
| <b>BLADE A</b> | <b>BLADE B</b> | <b>BLADE C</b> |

THE THREE BLADES ARE IN PERFECT CONDITION TO BE USED IMMEDIATELY

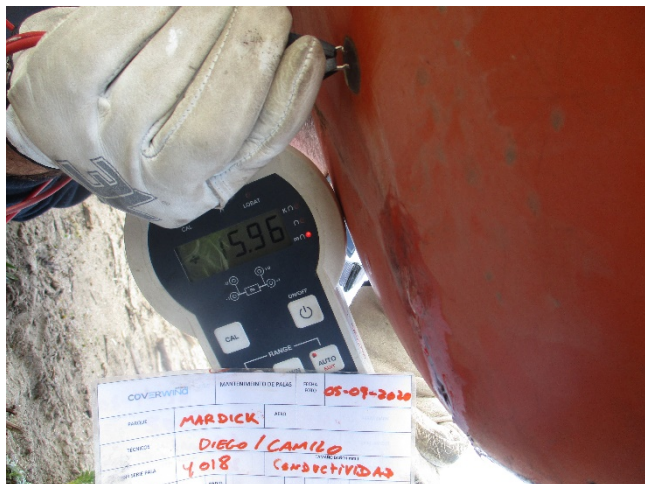
1- CONDUCTIVITY MEASUREMENT US

Conductivity measurement OK

MEASUREMENTS US: 15,96 - 15,95

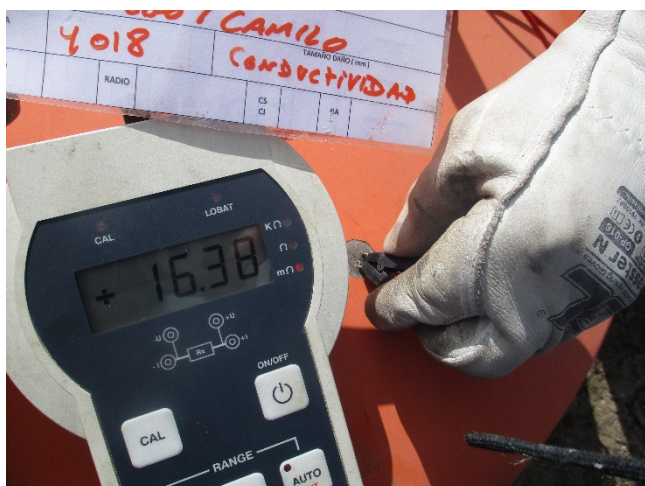
3- CONDUCTIVITY MEASUREMENT LS

MEASUREMENTS LS: 16,38 - 16,37

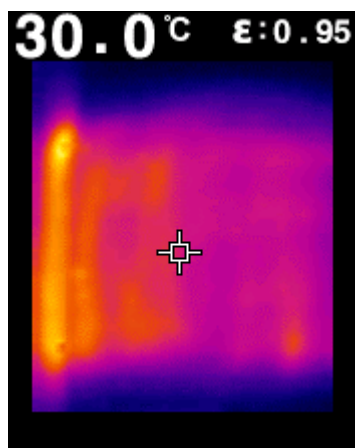
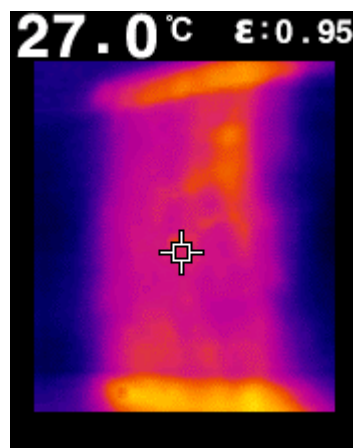
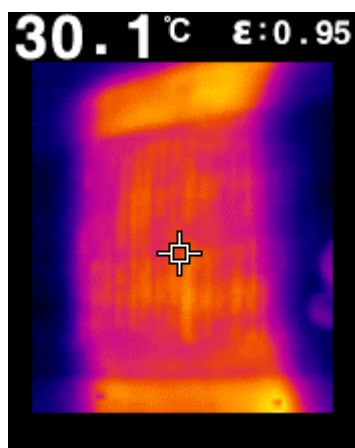
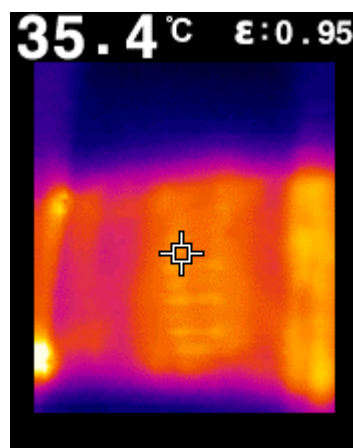
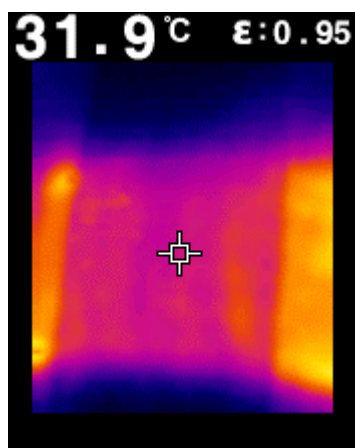
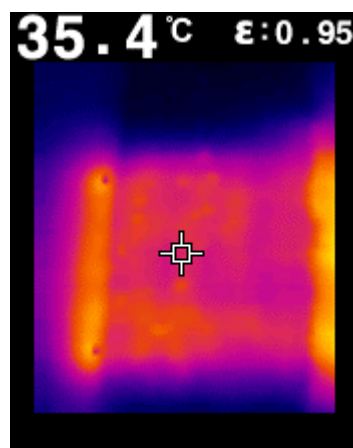
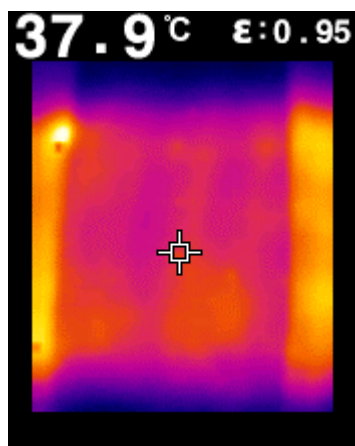
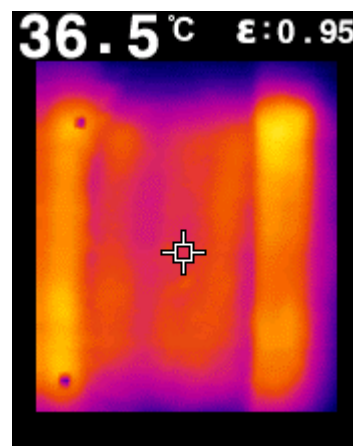
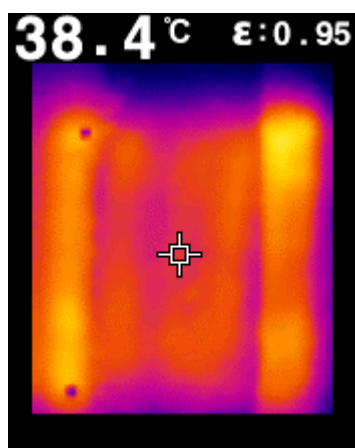
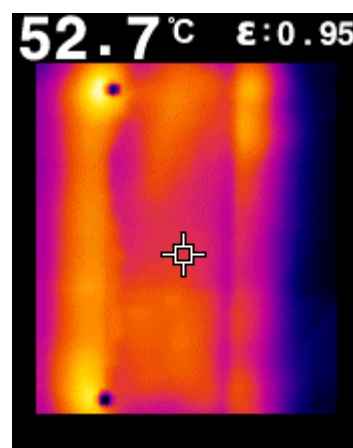
## 2 THERMOGRAPHY INSPECTION

Thermographic inspection and tap coin.

No damage found.

BLADE OK

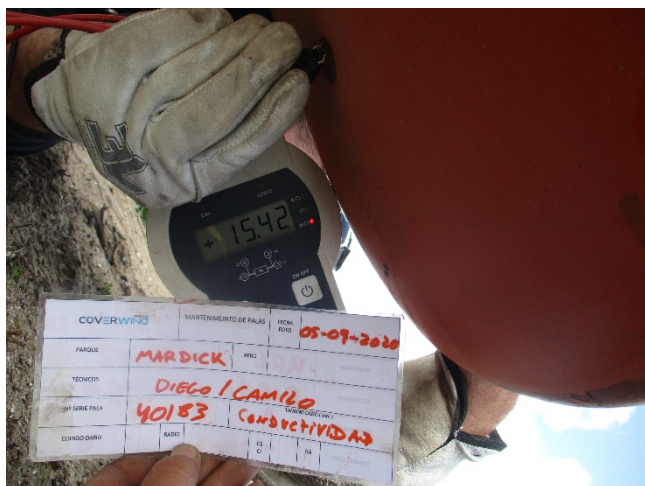
1- CONDUCTIVITY MEASUREMENT US

Conductivity measurement OK

MEASUREMENTS US: 15,42 - 15,59

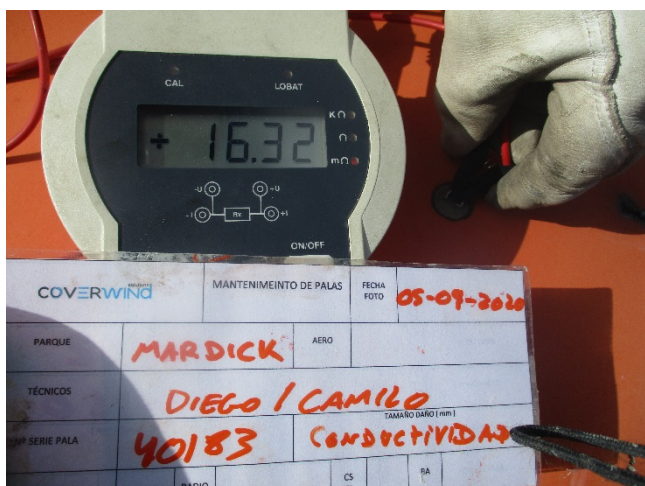
3- CONDUCTIVITY MEASUREMENT LS

MEASUREMENTS LS: 16,32 - 16,51

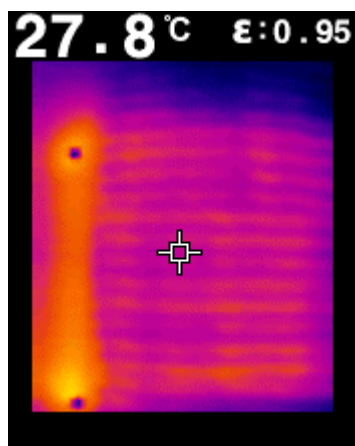
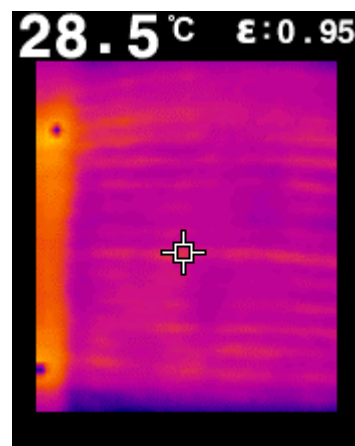
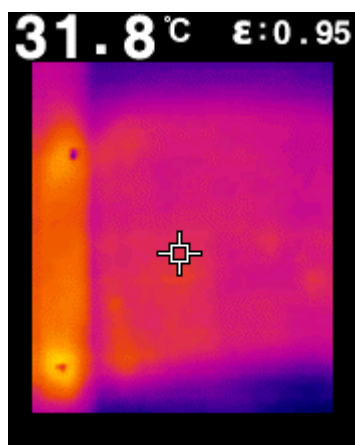
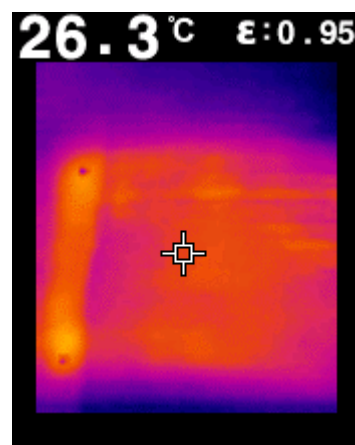
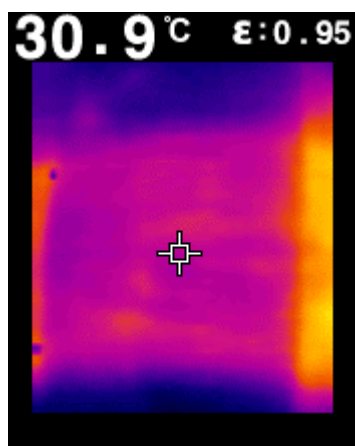
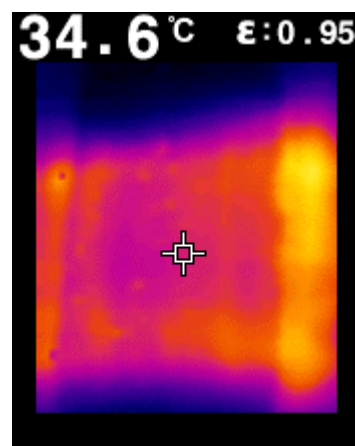
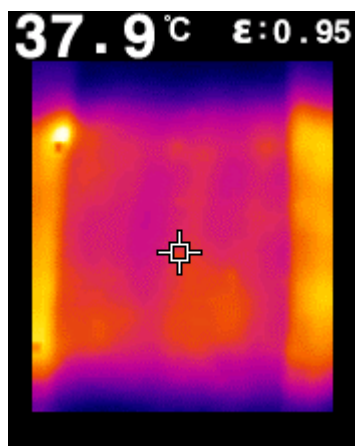
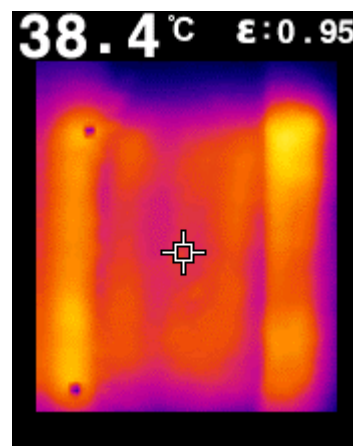
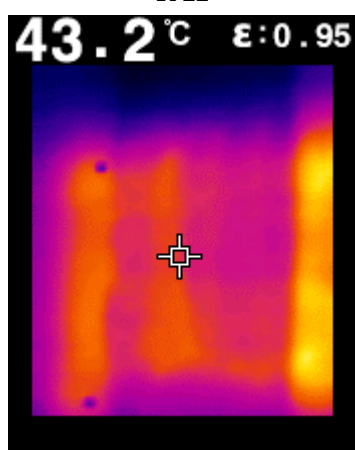
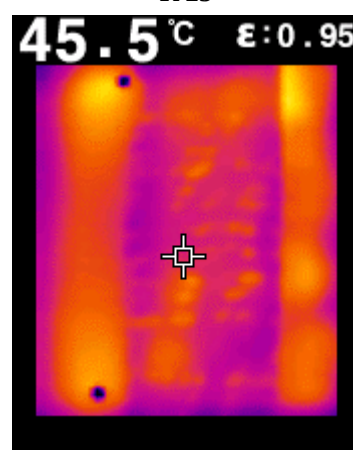
## 2 THERMOGRAPHY INSPECTION

Thermographic inspection and tap coin.

No damage found.

BLADE OK

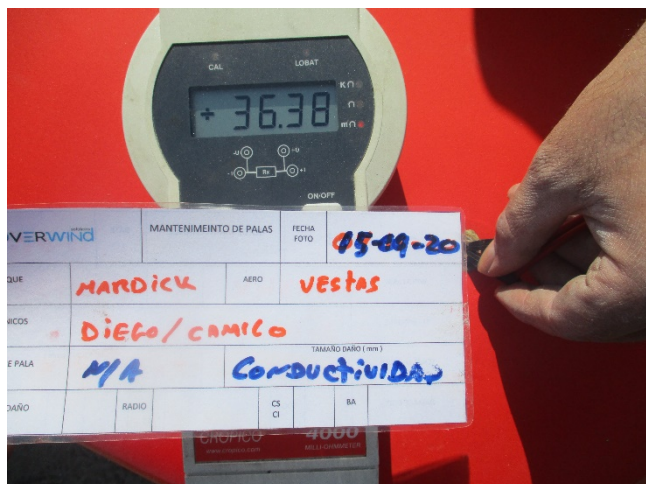
1- CONDUCTIVITY MEASUREMENT US

Conductivity measurement OK

MEASUREMENTS US: 36,38 - 26,04

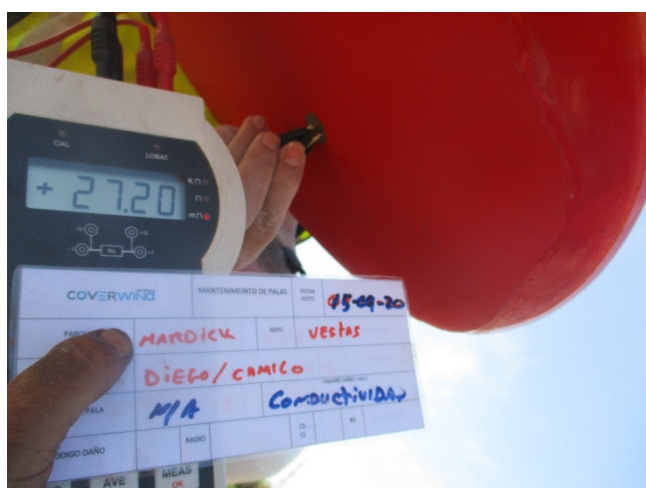
3- CONDUCTIVITY MEASUREMENT LS

MEASUREMENTS LS: 27,20 - 21,71

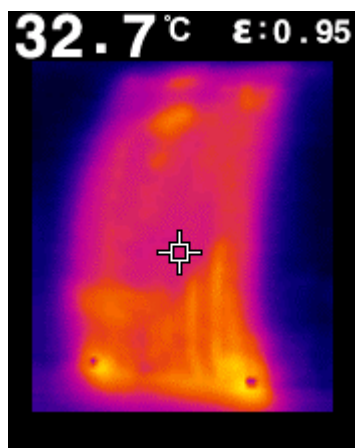
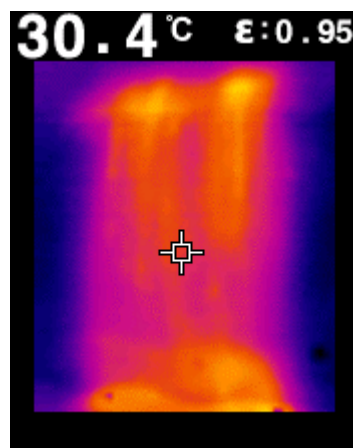
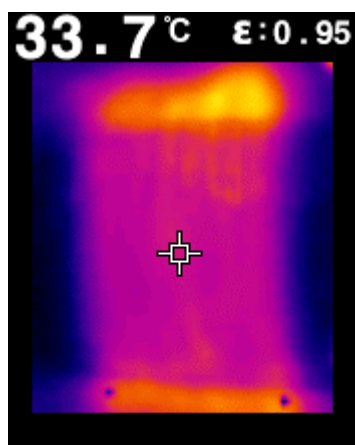
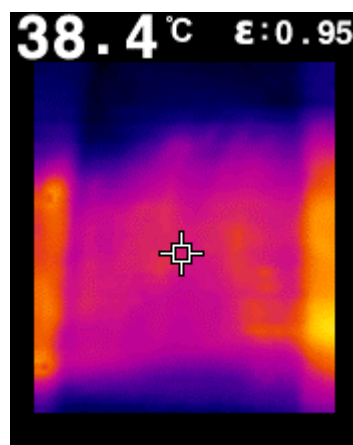
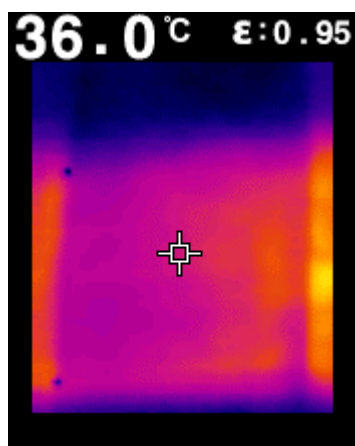
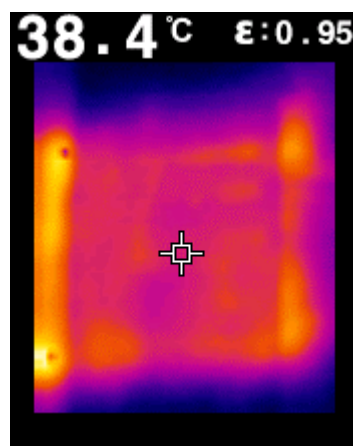
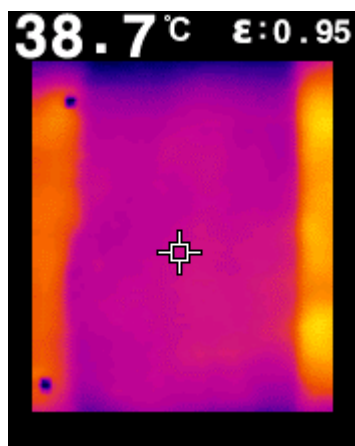
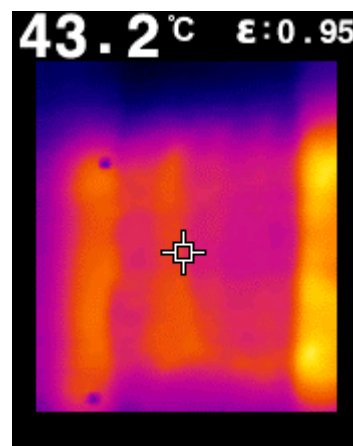
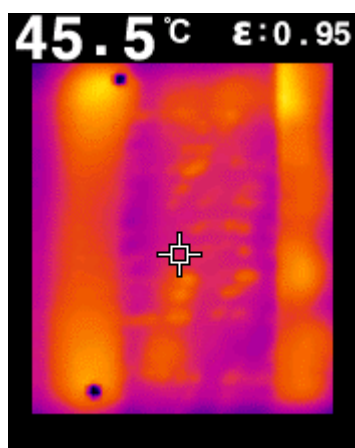
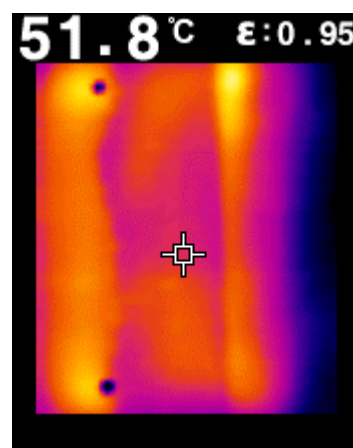
## 2 THERMOGRAPHY INSPECTION

Thermographic inspection and tap coin.

No damage found.

BLADE OK
