## BLADE REPORT

| | BLADE INSPECTION REPORT | Fecha:/Date: 17/09/20<br>Edición:/Edition: 00 |

| Scope of the repair: | BLADE INSPECTION | Intervention type: | GROUND |

| Type of WTG | VESTAS V80 |

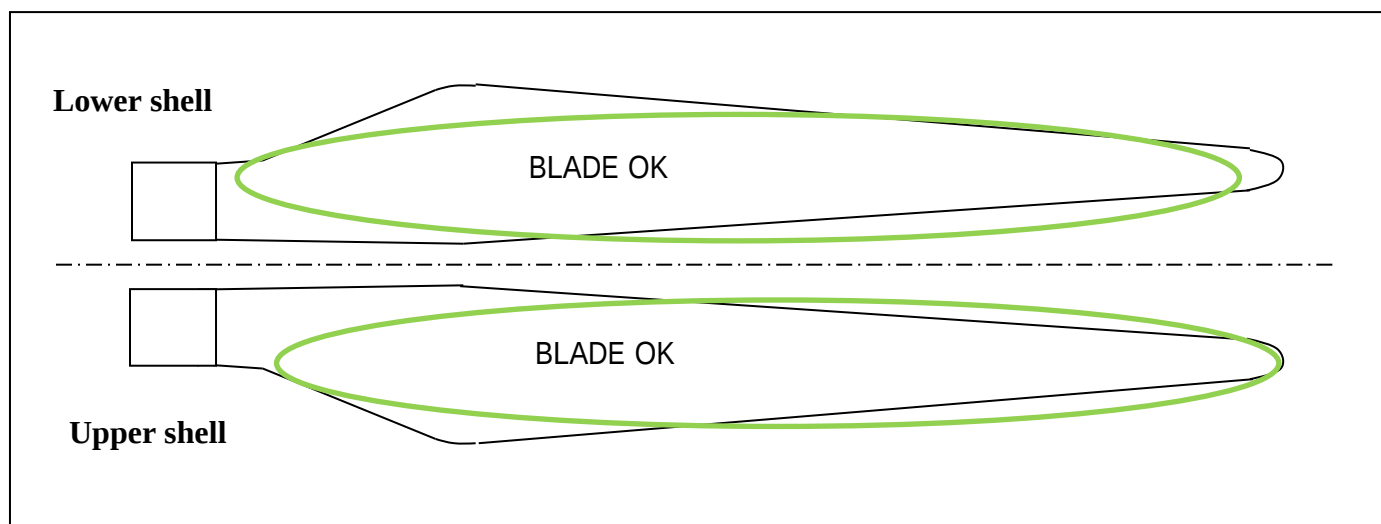
| Damage position | | | | | |

| Damage n° | Damage identification | | | | | | Description |
|---|---|---|---|---|---|---|---|
| 1 | 3.07 | | 45000 | 150 | | US<br>LS | CONDUCTIVITY MEASUREMENT |
| 2 | | | | | | | THERMOGRAPHY INSPECTION |

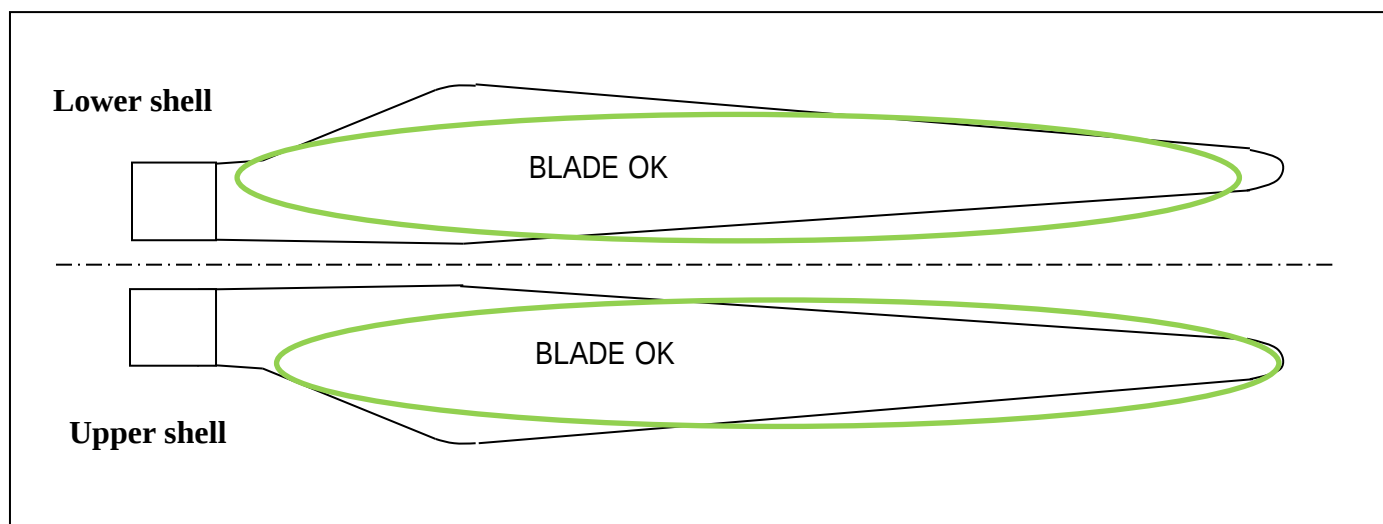
| Damage position | | | | | |

| Damage n° | Damage identification | | | | | | Description |
|---|---|---|---|---|---|---|---|
| 1 | 3.07 | | 45000 | 150 | | US<br>LS | CONDUCTIVITY MEASUREMENT |
| 2 | | | | | | | THERMOGRAPHY INSPECTION |
